***Report No. UT-03.34***

***FLEXURAL PERFORMANCE OF  
RETROFITTED REINFORCED  
CONCRETE CANTILEVERED  
BENT CAPS – PART 2***

**Utah Department of Transportation  
Research Division**

**December 2003**

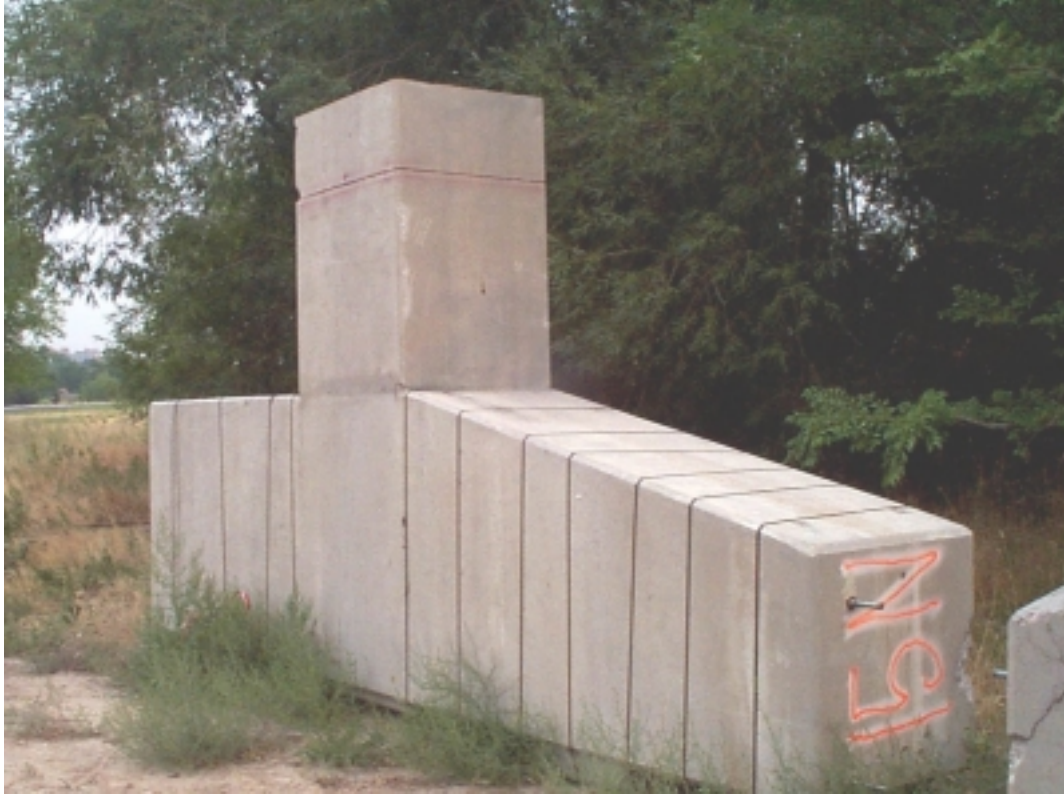
Bent 15N was in fairly good condition compared to the other bents. Figure 1.2 shows the East side of the bent, which was the most damaged side. Figure 2.1 shows the west side as well as the underneath part of the cantilever, both in “fairly” good condition.

Figure 2.1 – West side and underneath cantilever of Bent 15N

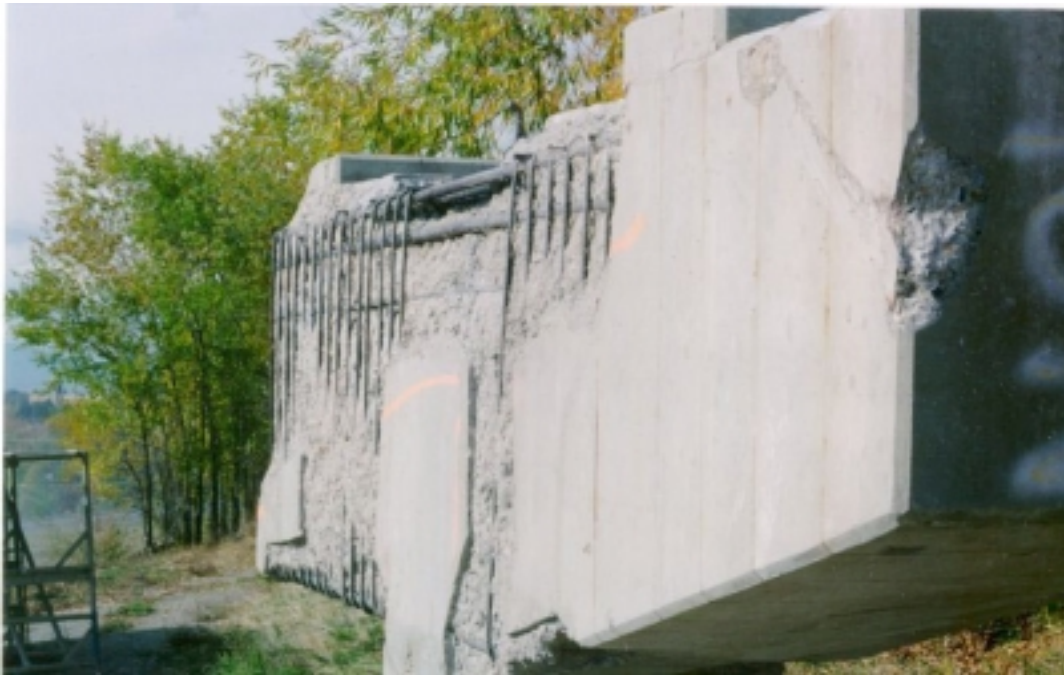
Figure 2.2 – East side of Bent 15N in pre-repair condition

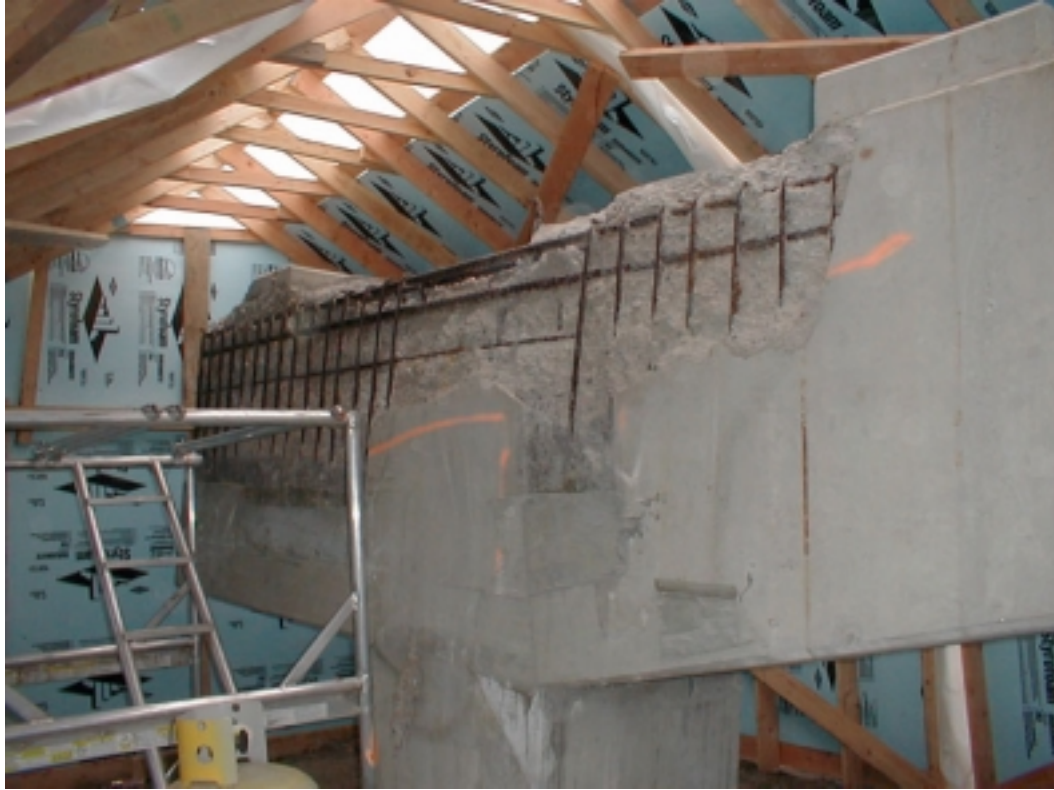
Figure 2.4 – Bent 15N with bottom portions patched

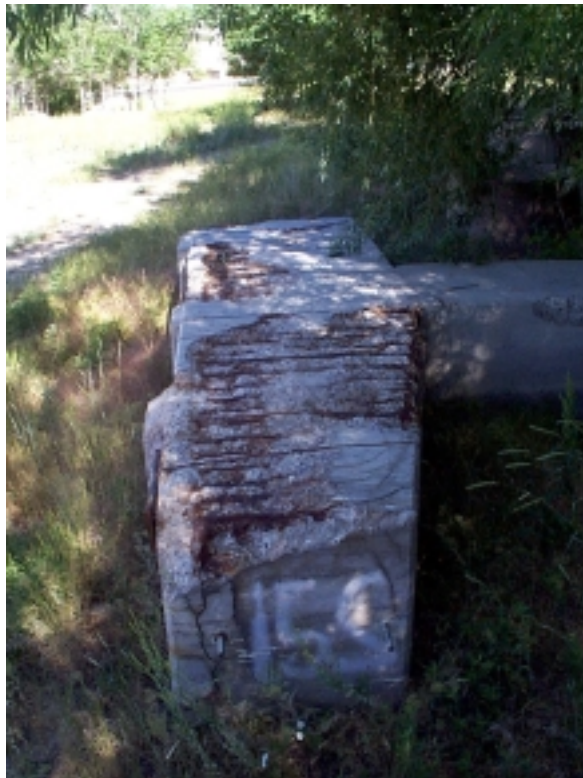
Figure 2.6b – Bent 15S, close-up of East face

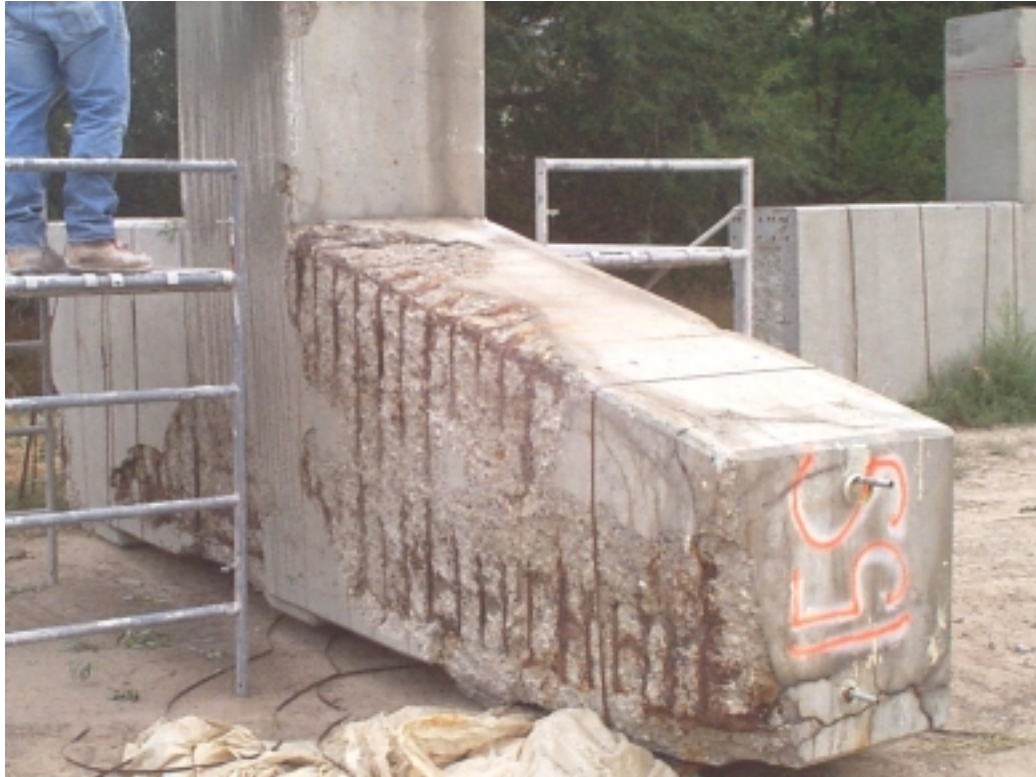
Figure 2.6c – Bent 15S, close-up of east face and underside of cantilever

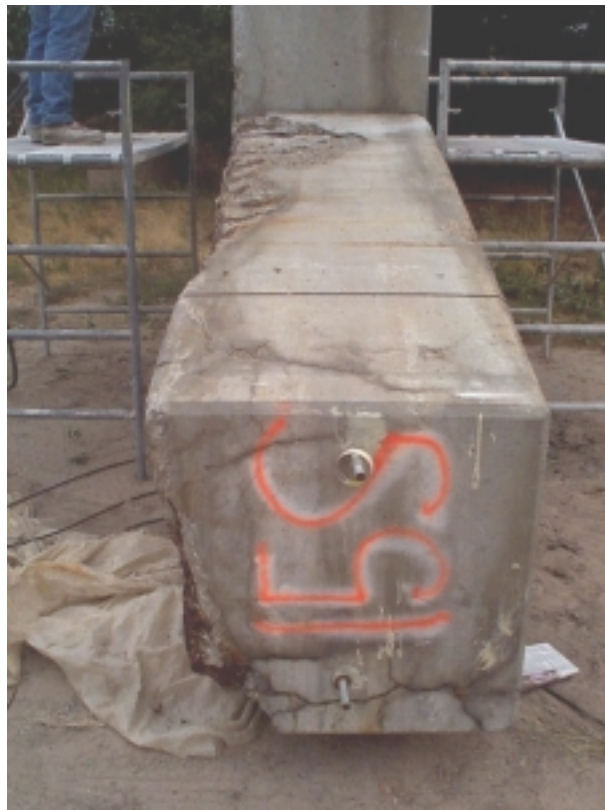
Figure 2.6d – Bent 15S, close-up of cantilever face and underside

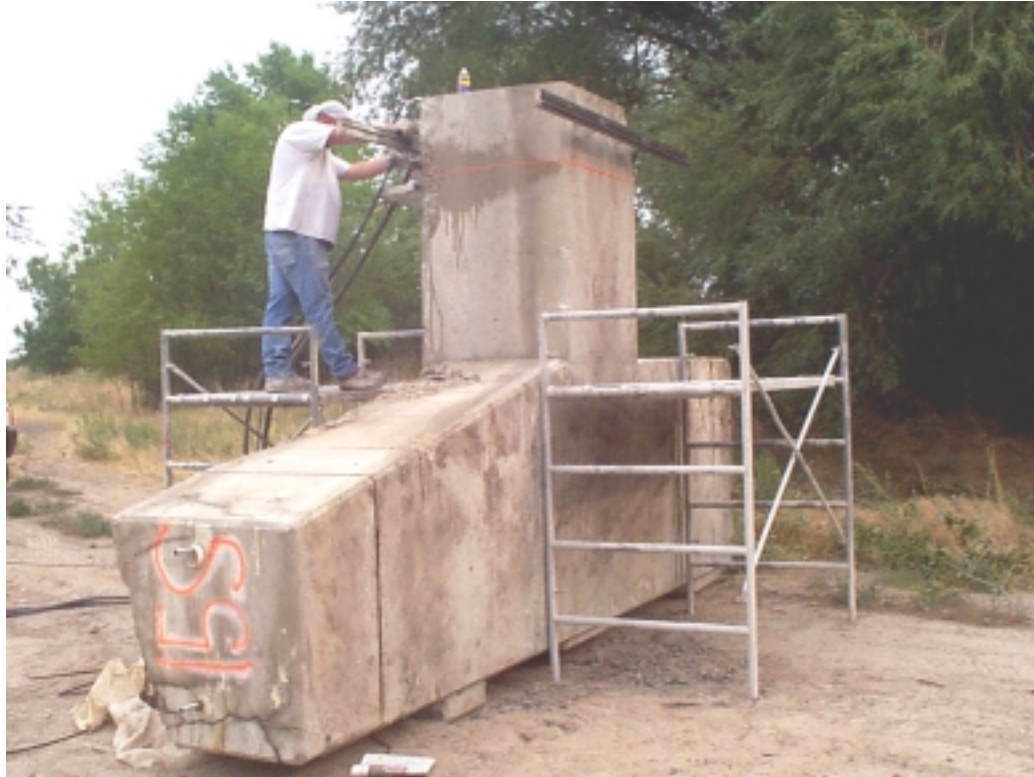
Figure 2.6e – Bent 15S, west face and underside of cantilever

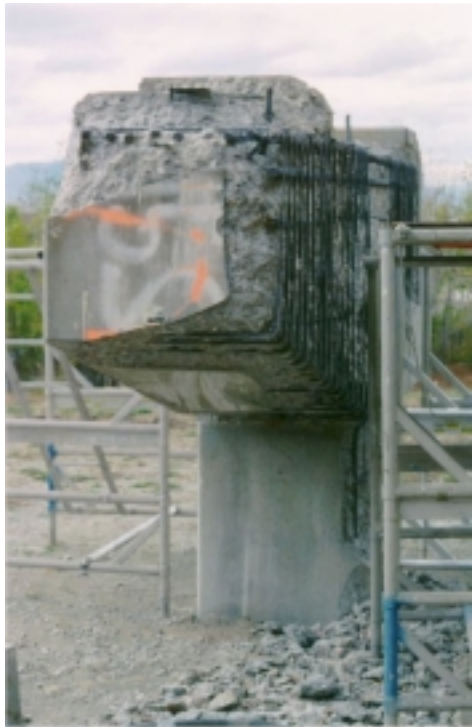
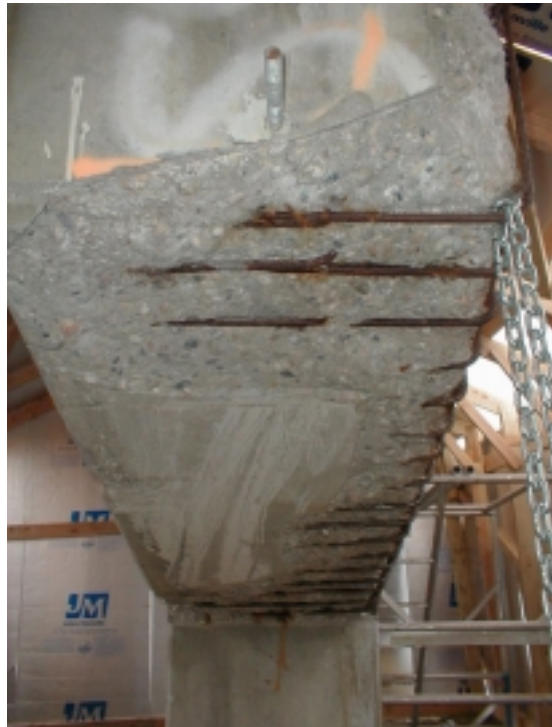
(a) East face

(b) Underside of cantilever

Figure 2.7 – Bent 15S after loose concrete chipped away

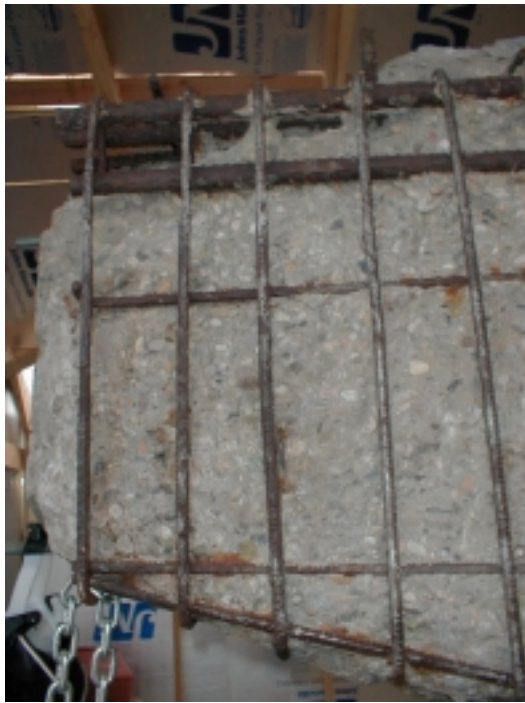
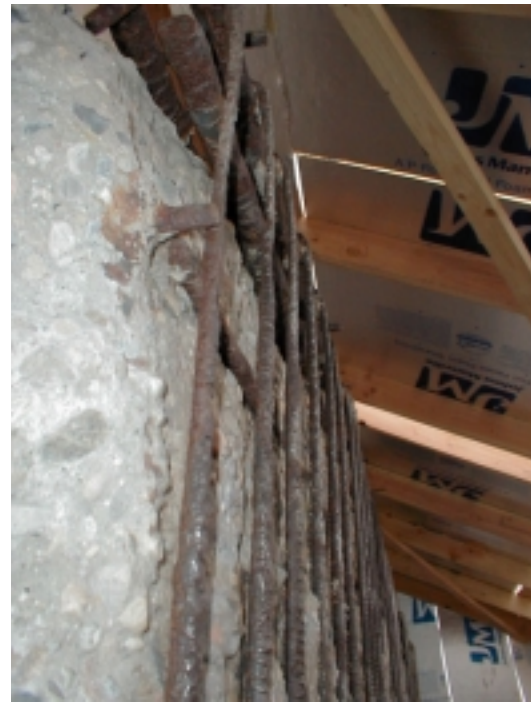
(a) Cantilever tip

(b) Close-up of shear reinforcement

Figure 2.8 – Rebar fully exposed on Bent 15S

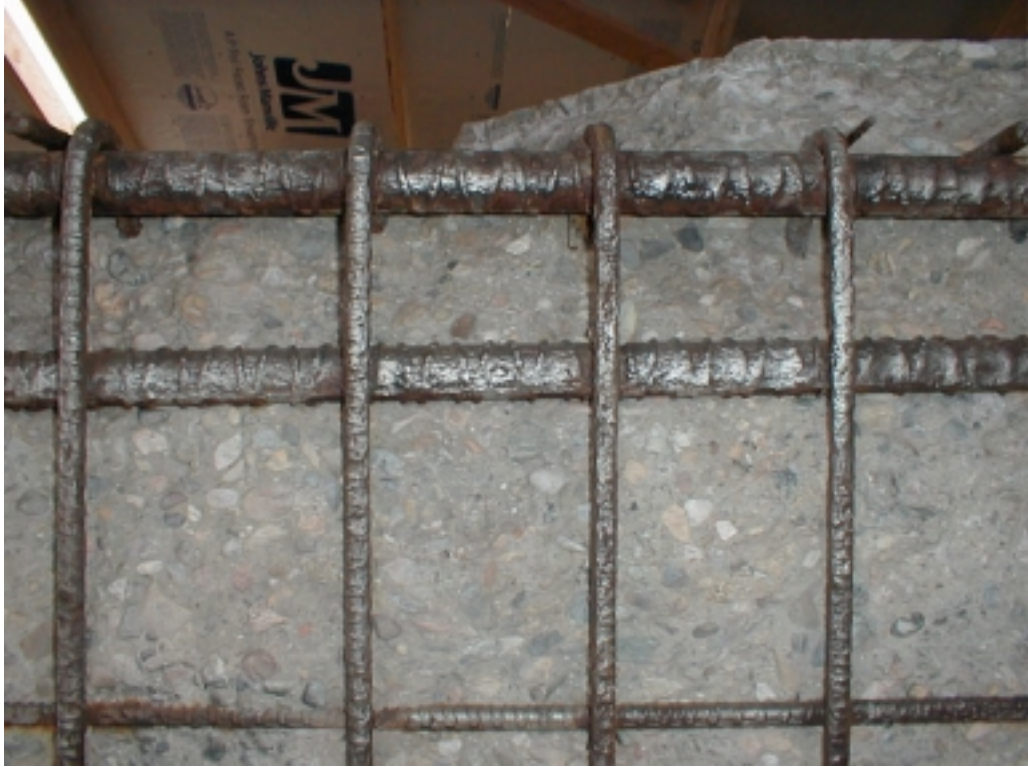
Figure 2.10 – Rebar on Bent 15S after removal of rust

As with Bent 15N, the rust was taken off the rebar with a grinder before any concrete was poured. Figure 2.10 shows the condition of the rebar after grinding. After the rust was removed, the exposed areas of the bent were coated with a bonding agent—to help the new concrete bond with the old. Forms were constructed around the bottom of the bent and the concrete was poured. Figure 2.11 shows Bent 15S after the forms had been installed and the bonding agent had been applied.

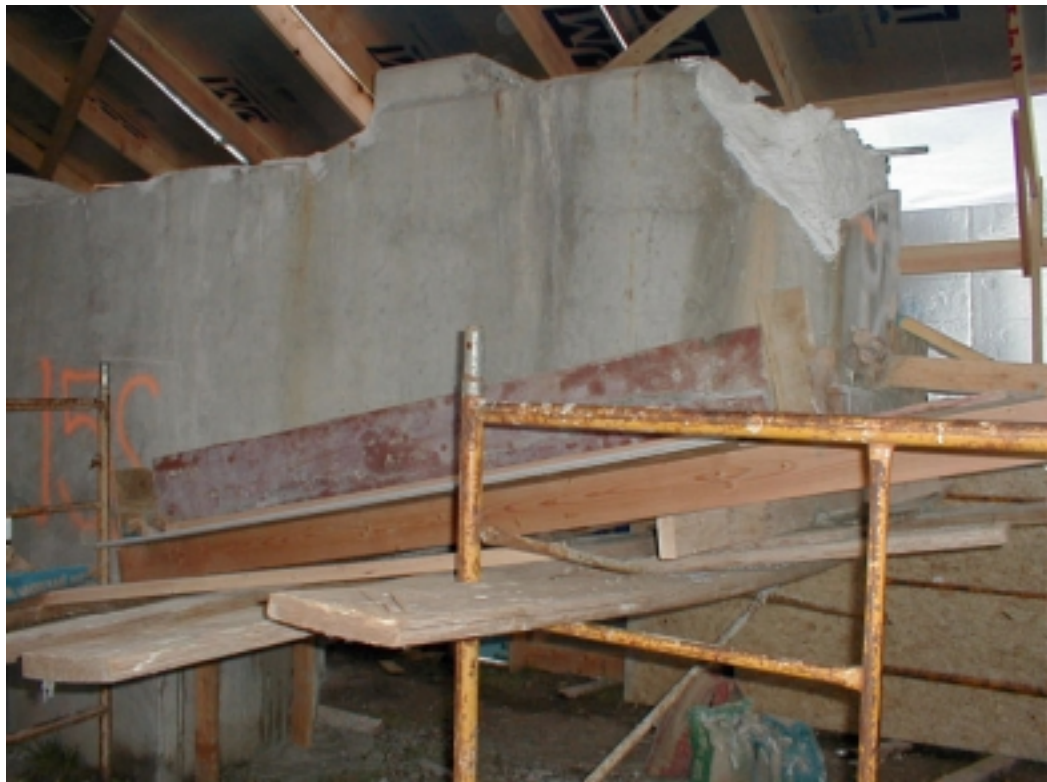
Figure 2.13 – New forms on Bent 15S to fix void gaps

When the forms were removed there were small pockets in the concrete as seen in Figure 2.12. To remedy this, new forms were built around the edge of the bent leaving a 1.5-inch (38 mm) gap between the surface of the bent and the form. Concrete was placed again to fill these small pockets. Figure 2.13 displays the newly built forms and Figure 2.14 shows the edge of the bent after the forms were removed. The 1.5-inch (38 mm) edge shown in Figure 2.14 was then chipped away using a chisel and grinder so that it was flush with the rest of the bent.

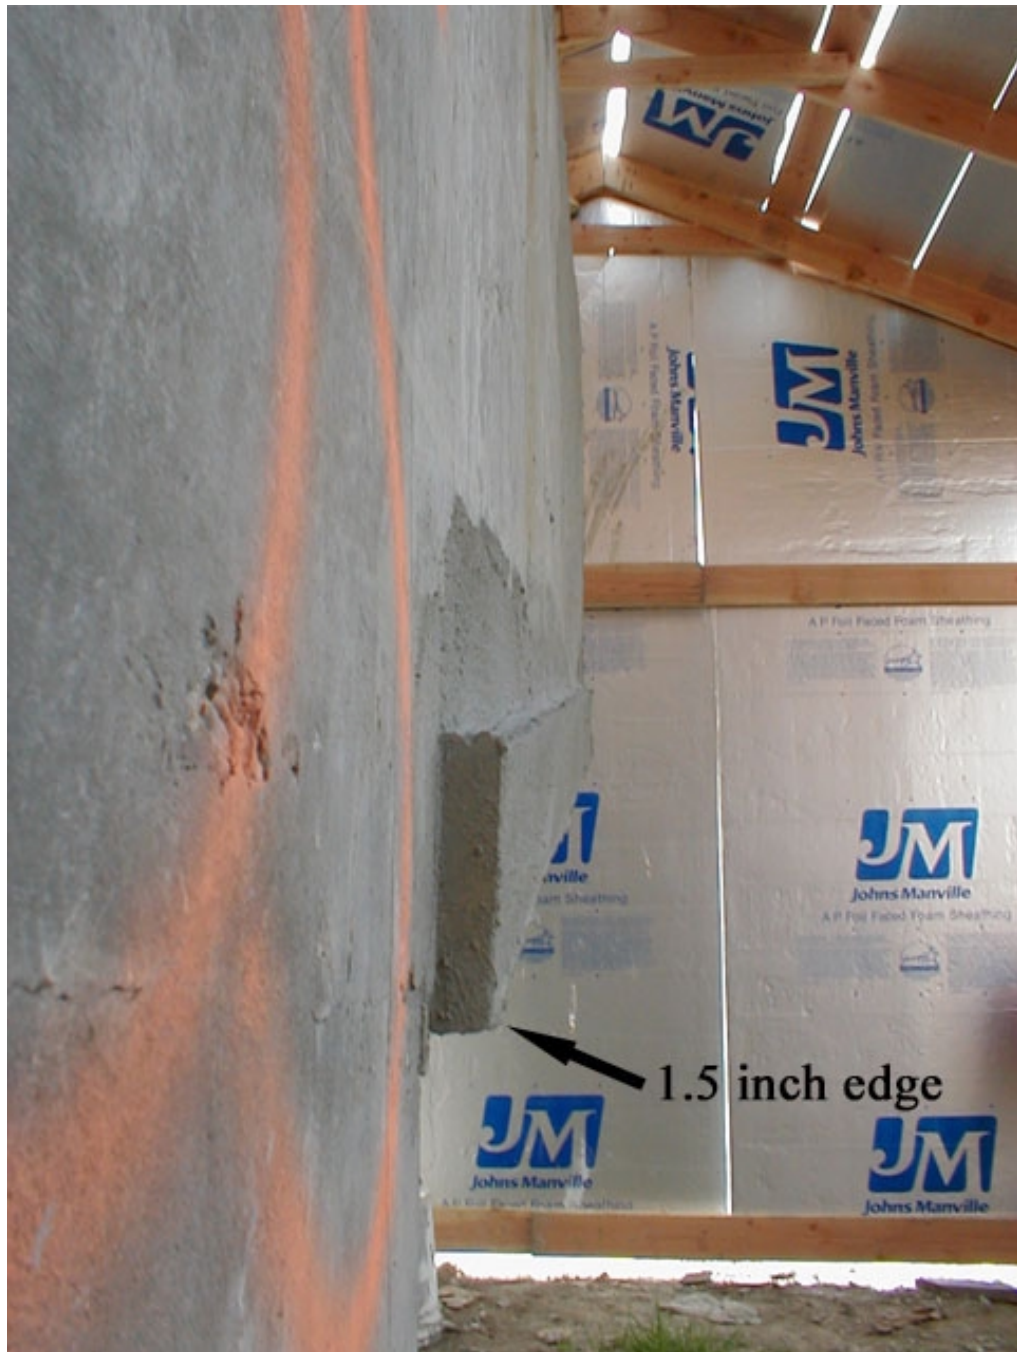
Figure 2.14 – Edge of Bent 15S

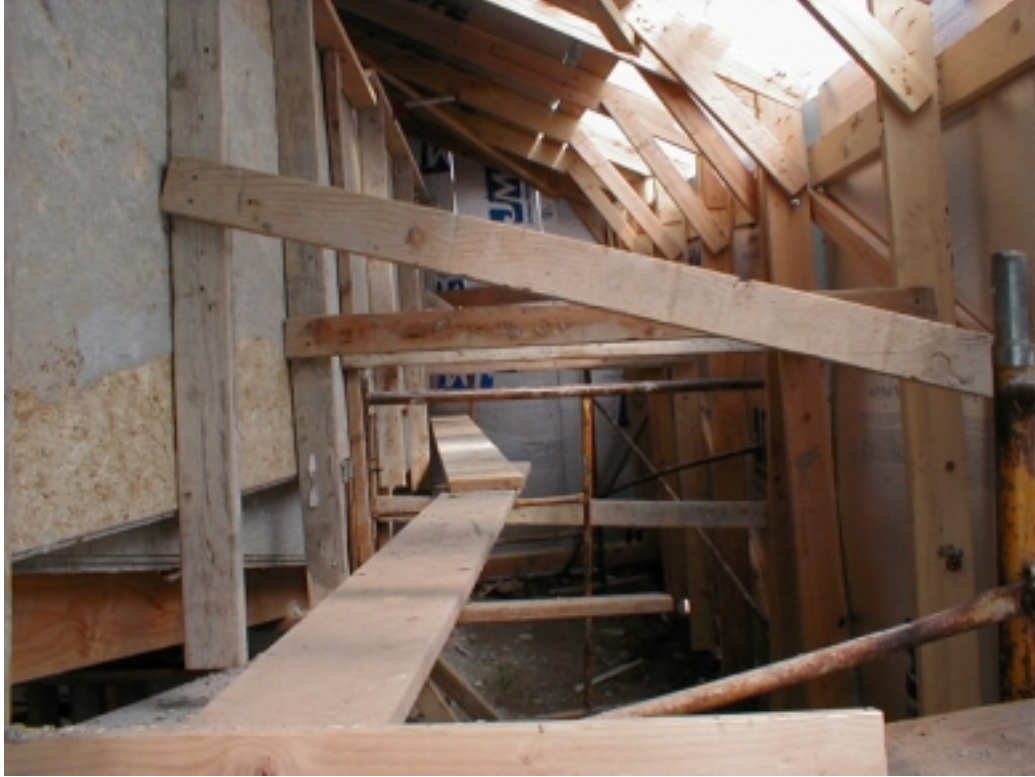
Figure 2.15 – Concrete forms on Bent 15S

Finally, forms were constructed around the sides of the bent as shown in Figure 2.15, and concrete was placed down the sides and on top of the bent. The fully repaired bent is shown Figures 2.16-2.18.

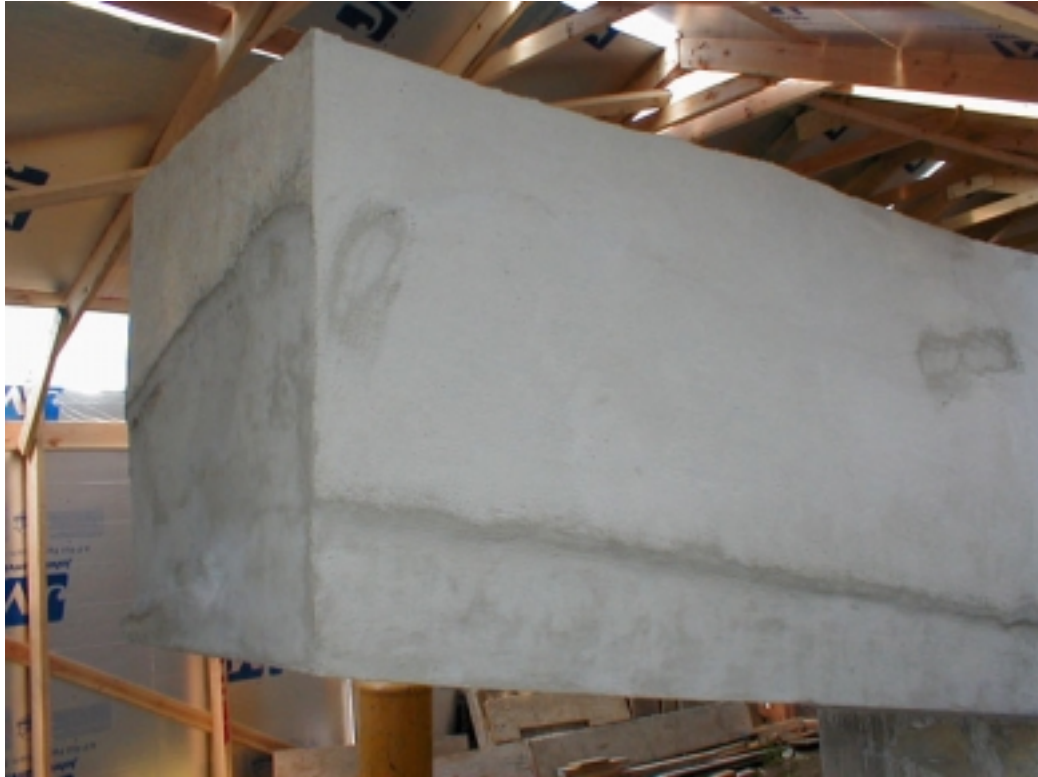
Figure 2.17 – Cantilever of repaired Bent 15S

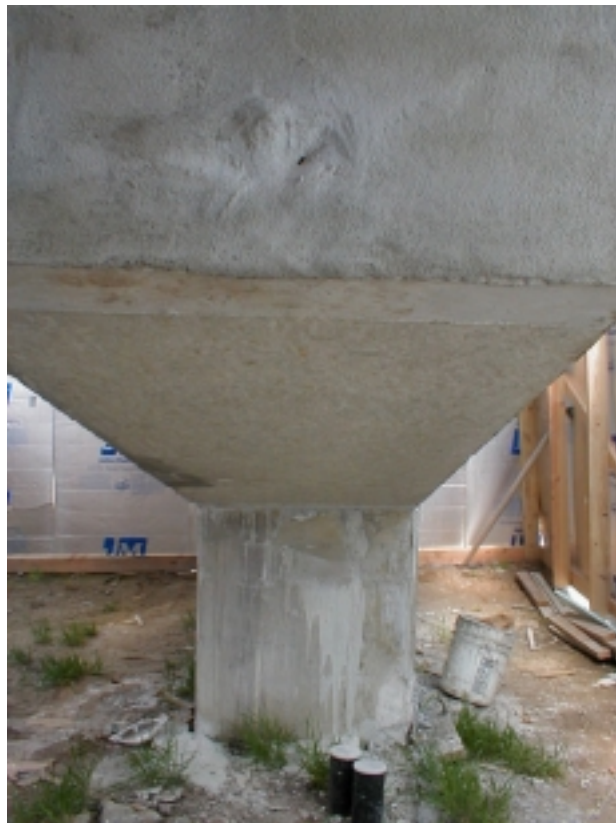
Figure 2.18 – Underside of cantilever of repaired Bent 15S

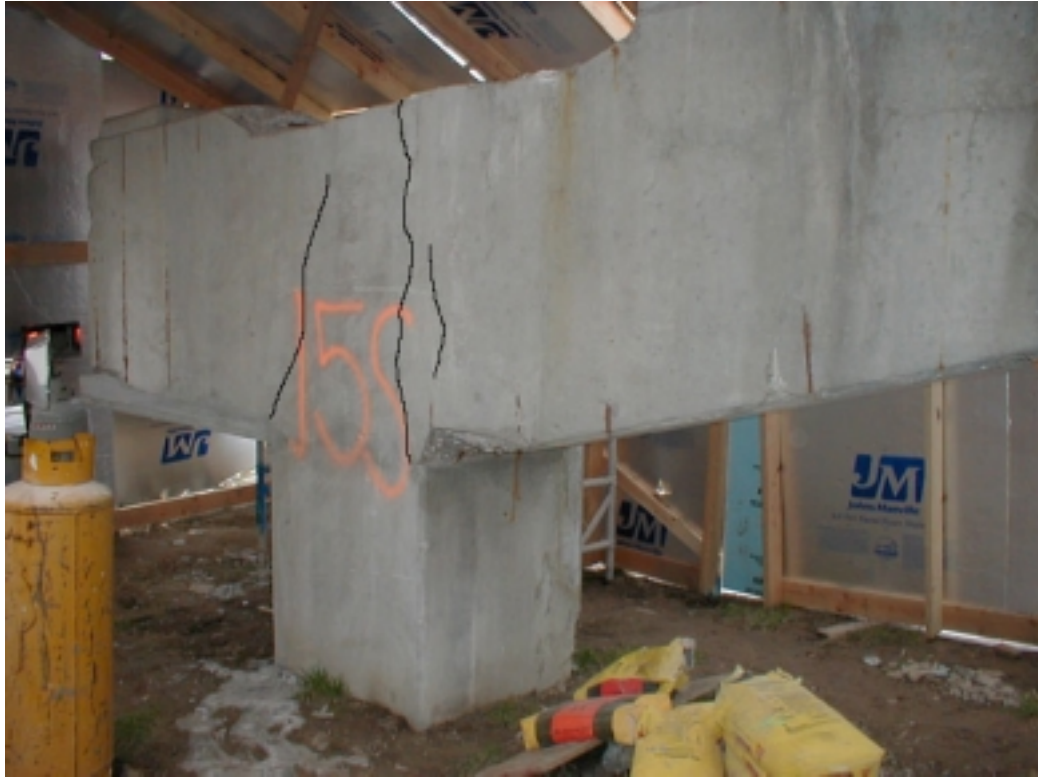
Figure 2.19 – Bent 15S before repair (cracks drawn on picture)

After the bent was repaired with the concrete patch, some pre-existing cracks in the West face of the bent, as shown in Figure 2.19, were epoxy injected. A full description of the epoxy injection method is discussed in section 2.2.1 of this report.

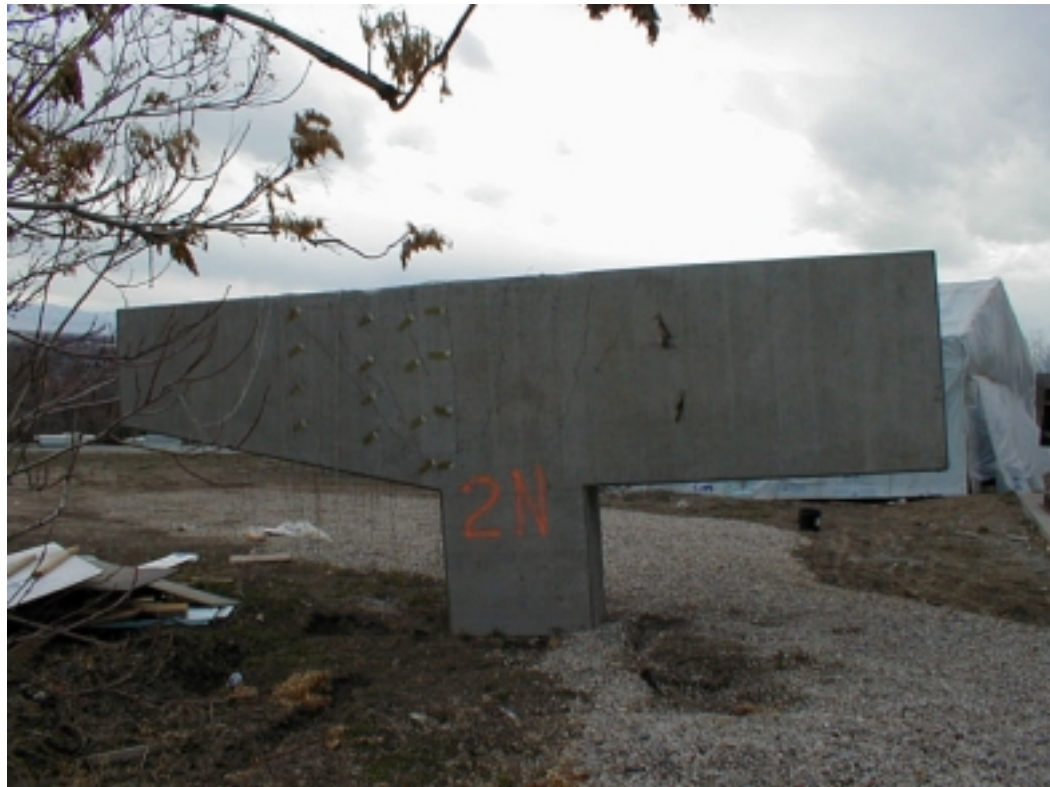
Bent 2N was in very good condition because of its new construction (Figures 2.20 and 2.21). The construction of this bent is discussed by Rowe (2001). The pre-yield test of Bent 2N caused several cracks to form; these cracks are highlighted in Figure 2.22. Besides these cracks, no other visible damage was caused by the pre-yield tests. The repair of Bent 2N consisted simply of epoxy injecting the cracks.

Figure 2.21 – West side of Bent 2N

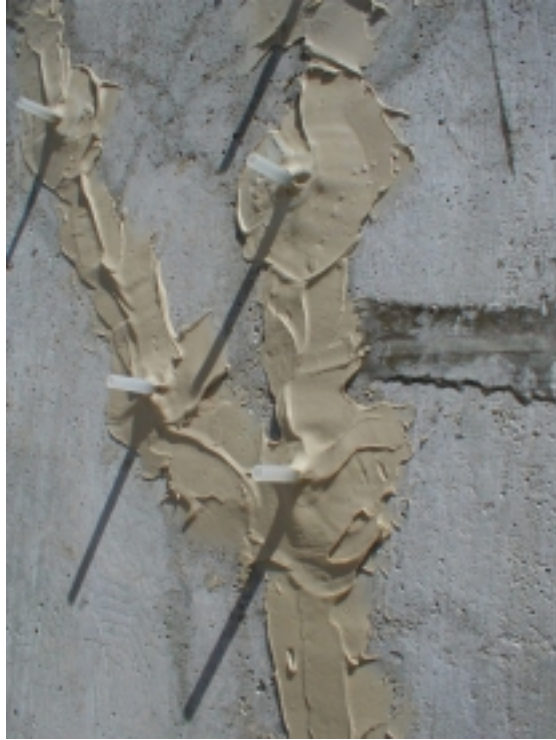
Figure 2.23 – Epoxy injection tubes and surface seal on Bent 2N

The first step in the epoxy injection method was to grind the concrete along the cracks. This was done to clean the surface along the cracks so that the cracks could be clearly seen. Next, small hollow tubes were inserted along the cracks about every 6 to 18 inches (152-457 mm). After the tubes were in place, the cracks were sealed so as to prevent leaking out of the epoxy at the surface during epoxy injection. The epoxy was then injected into the cracks through these hollow tubes. Figure 2.23 shows the hollow tubes and surface seal along a crack. Finally the epoxy was injected into the cracks through the tubes. Tyfo 103 Regular Injection Epoxy (see Appendix A for material specifications and properties) was used.

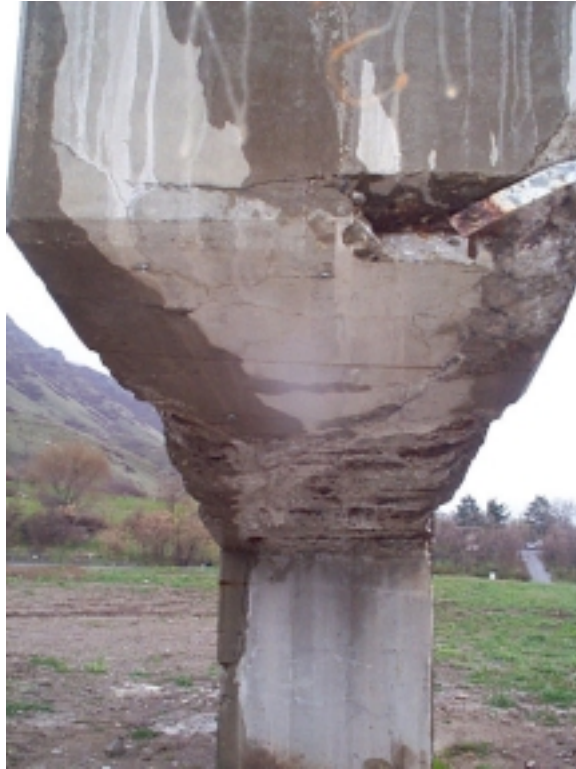
Bent 12N was an “old” bent and was therefore in worse condition than Bent 2N. Figures 2.26-2.28 show the condition of the bent before repair. As can be seen in Figures 2.27 and 2.28, the concrete on the underside of the sloped cantilever end was severely spalled to the point of exposing some of the reinforcement. The exposed rebar was partially corroded.

Figure 2.27 – Underside of the cantilever of Bent 12N before repair

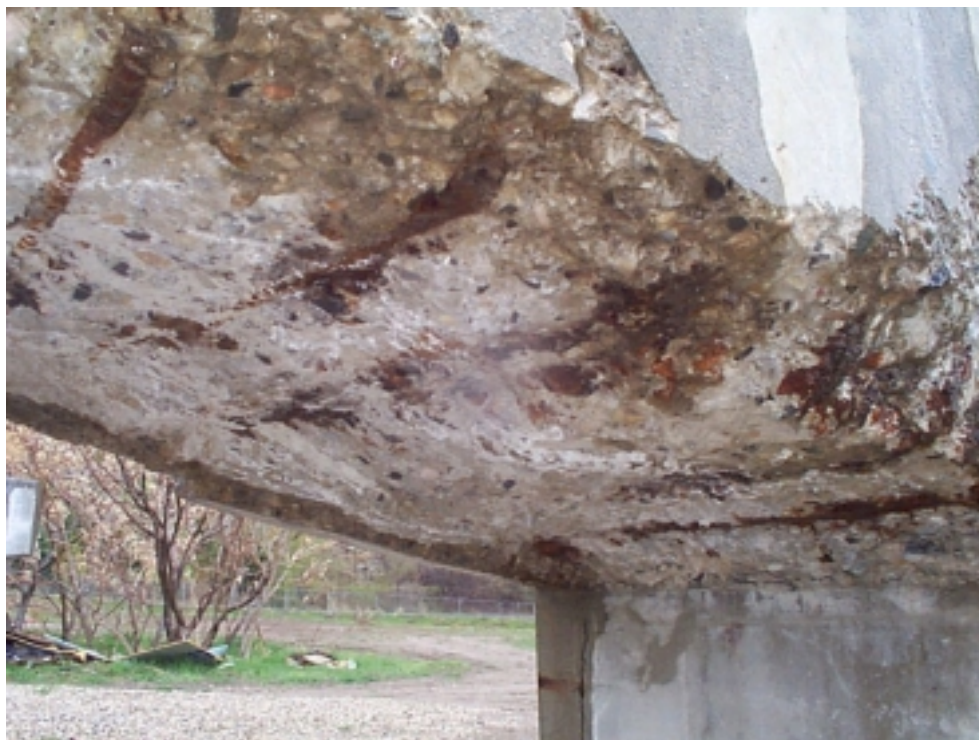
Figure 2.28 – Intersection of the cantilever and column of Bent 12N before repair

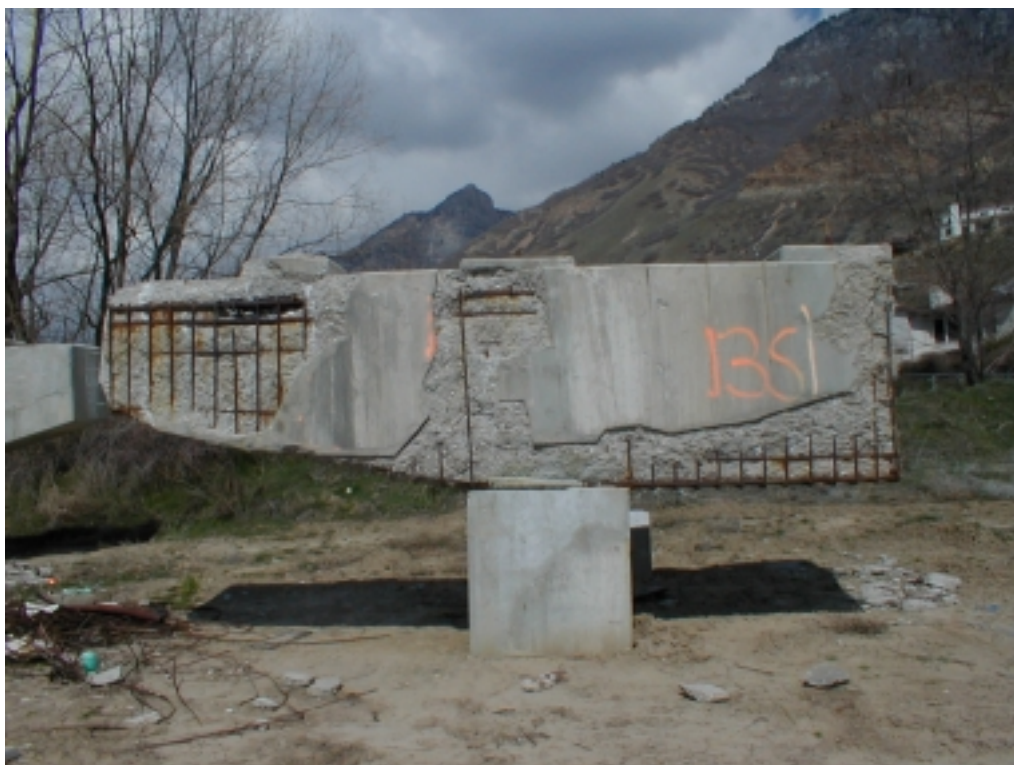
Figures 2.29-2.31 show the bent after removing unsound concrete. There was a significant amount of reinforcement exposed on the East side of the bent with many of them considerably corroded. Figure 2.32 shows the amount of exposed reinforcement corrosion in the bent. The numbering shown represents the approximate percentage of remaining area. There were three vertical and one horizontal bars that were completely corroded (these bars are represented in Figure 2.32 by 0% rebar remaining). These bars were removed as shown in Figure 2.36 and not replaced.

Figure 2.29 – East side of Bent 13S before repair

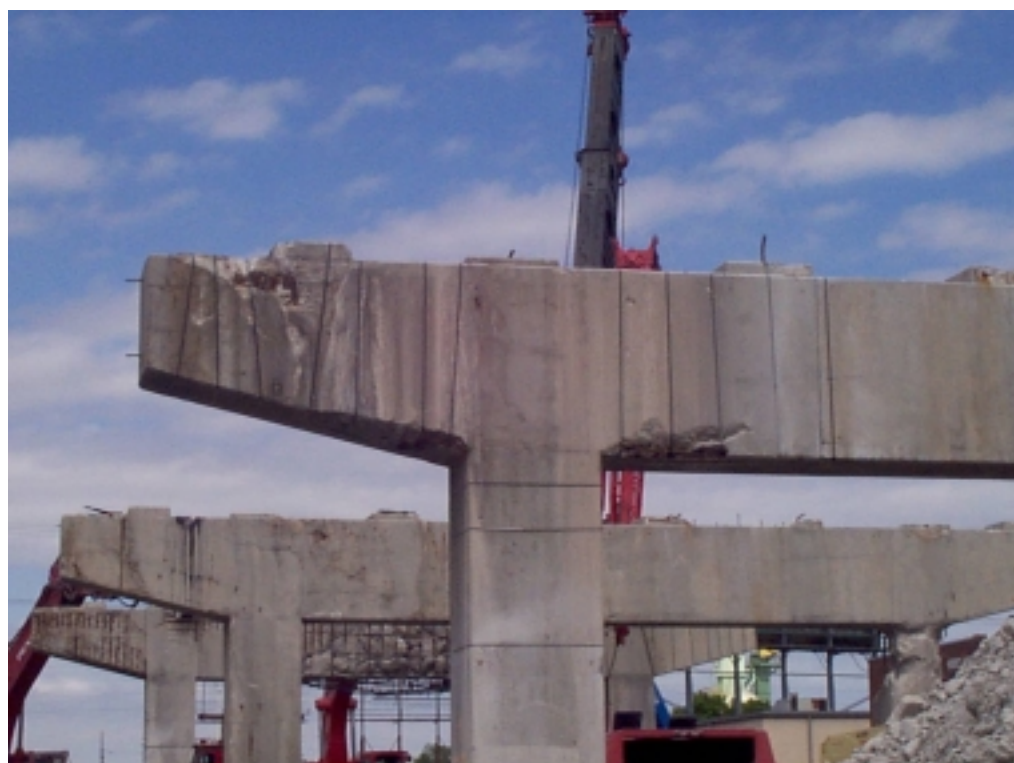
Bent 13S was an old bent that was in poor condition. Figures 2.29a through 2.29d show the bent in place, the East face and underside of the cantilever, the face and underside of the cantilever, and the West face of the bent, respectively. There was a significant amount of concrete spalling as well as some corroded reinforcement.

Figure 2.29a – Bent 13S in place

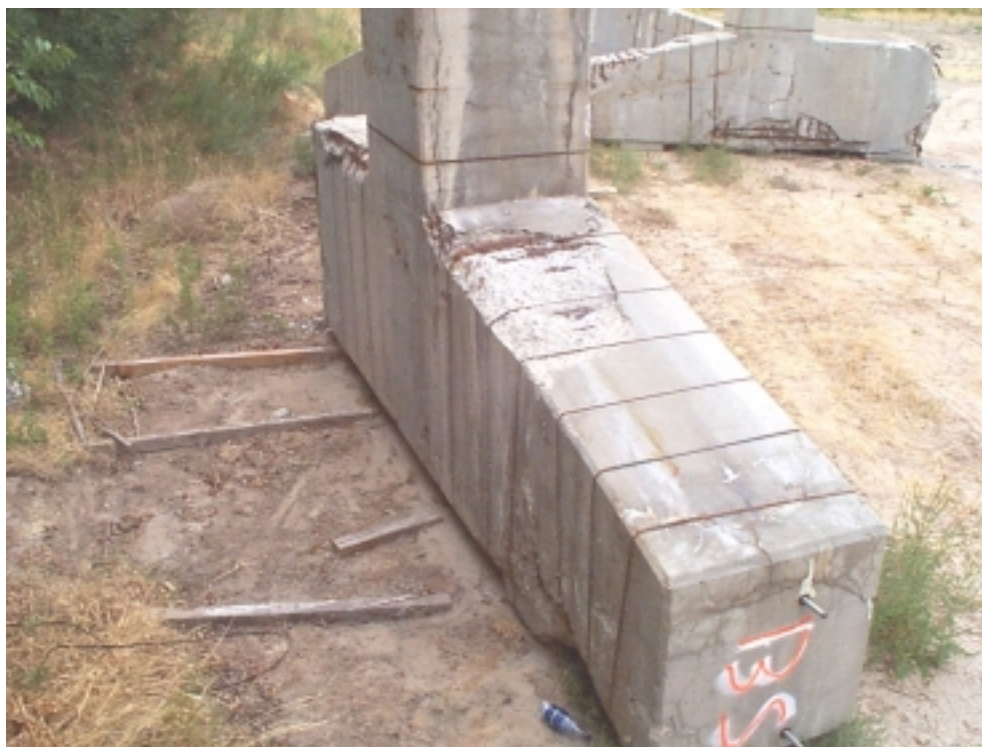
Figure 2.29b – Bent 13S, East face and underside of cantilever

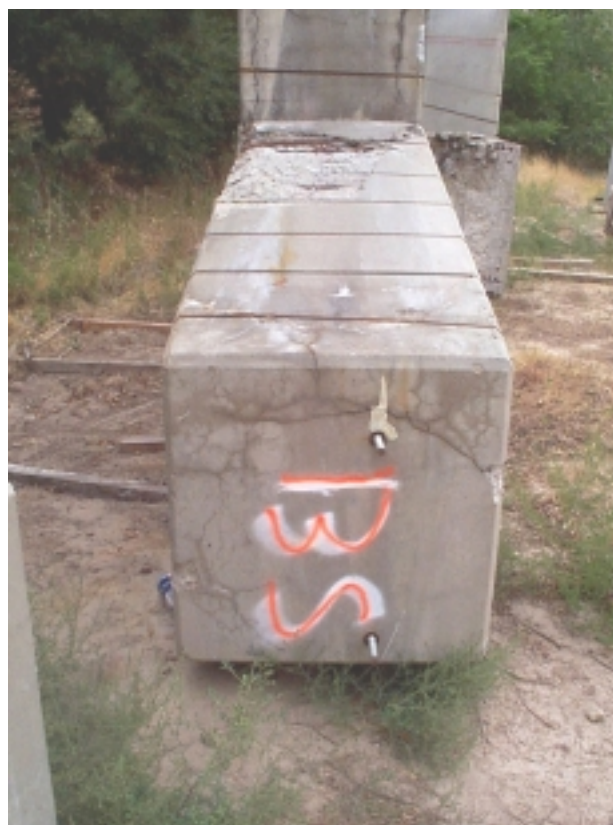
Figure 2.29c – Bent 13S, face and underside of cantilever

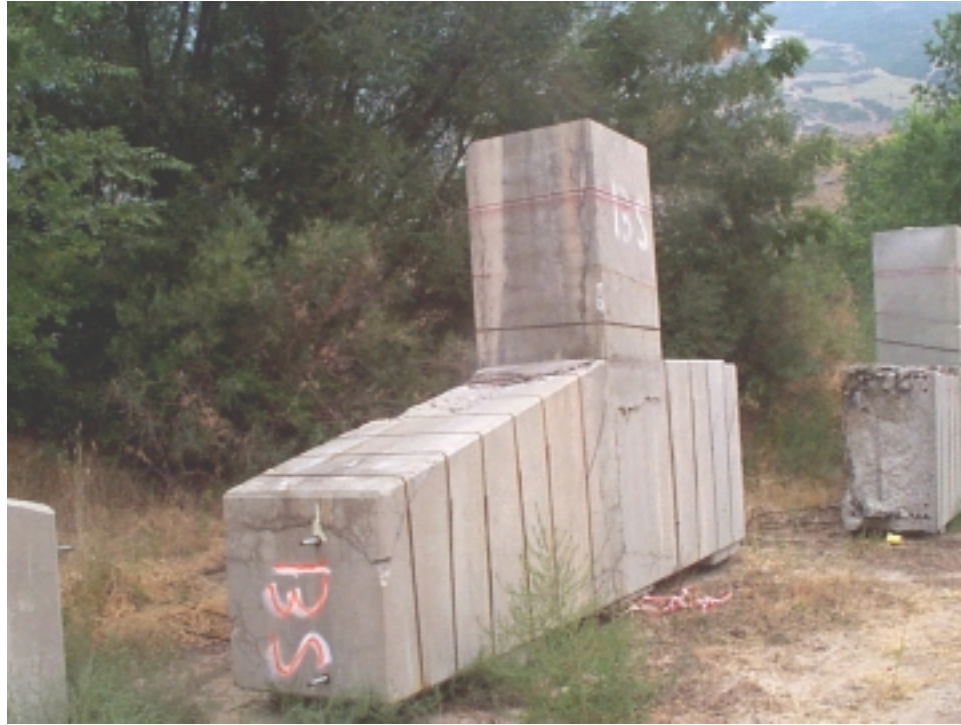
Figure 2.29d – West face of Bent 13S

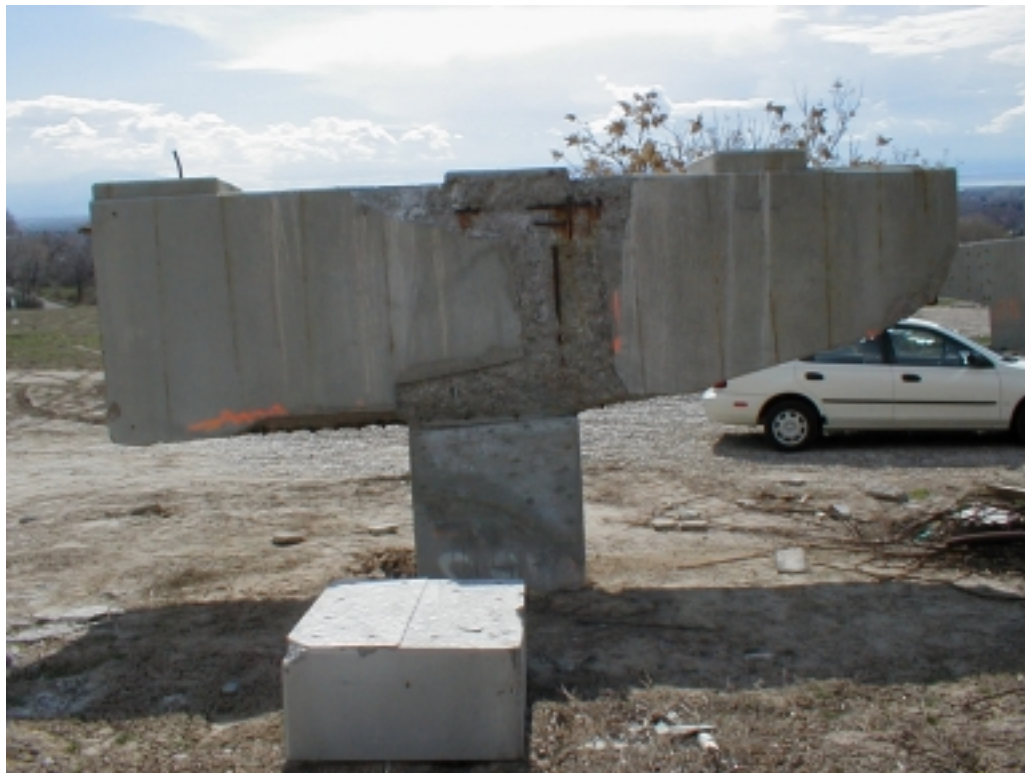
Figure 2.30 – West side of Bent 13S before repair

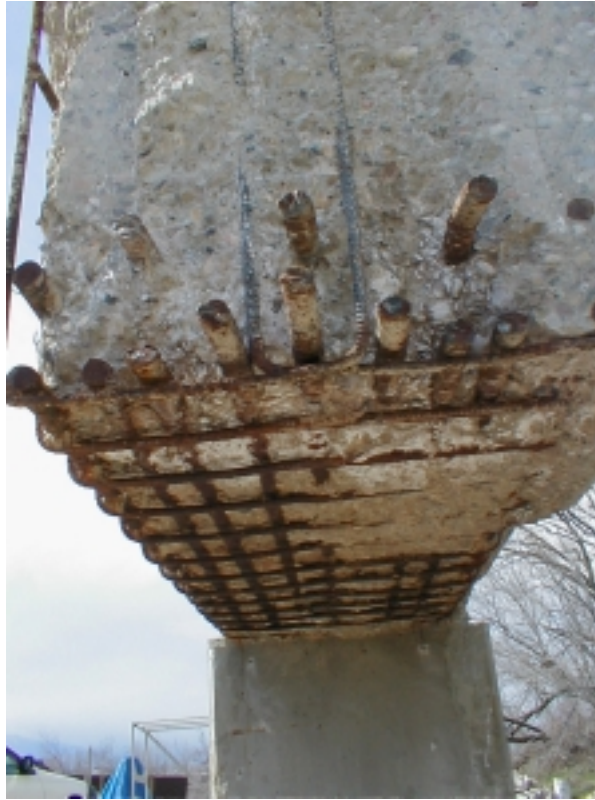
Figure 2.31 – Underside of the non-cantilever of Bent 13S before repair

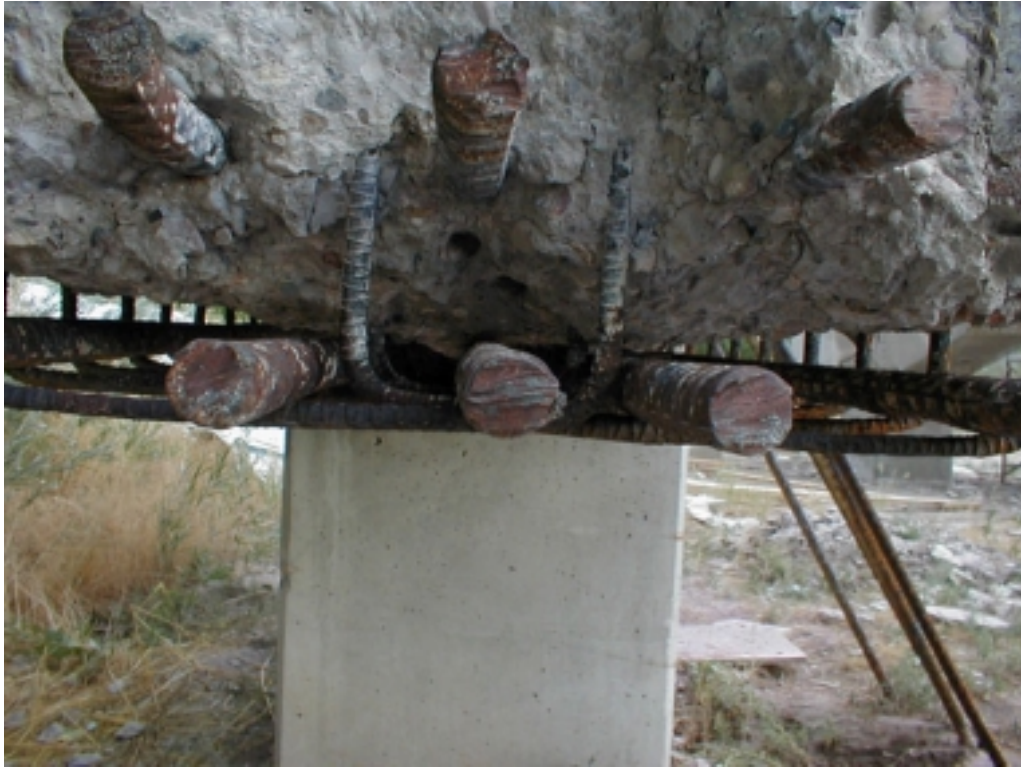
Figure 2.33 – Concrete chipped away around rebar on Bent 13S

As with the other bents, the first step in repairing Bent 13S was to chip away the concrete around the exposed rebar. As can be seen in Figures 2.33, careful consideration was taken to fully expose the reinforcement by chipping away approximately 1.5 inches (38 mm) of concrete around it. Figures 2.34-2.36 show the condition of the bent after the concrete was completely chipped away.

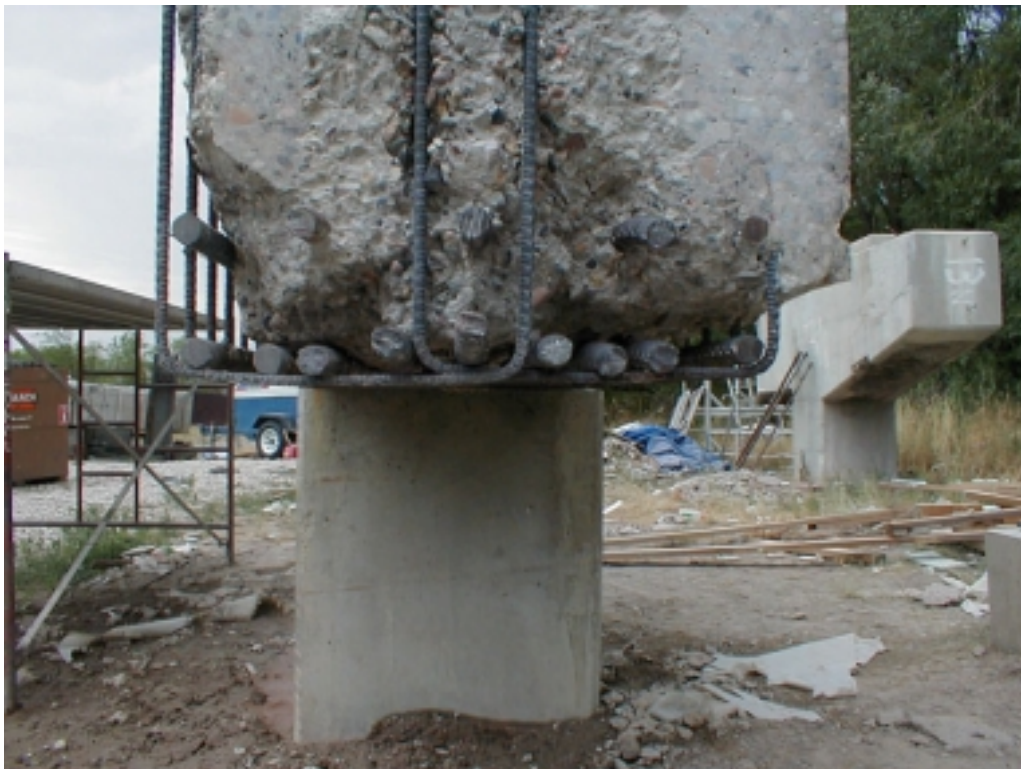
Figure 2.34 – Condition of Bent 13S after concrete was chipped away
